Hazardous Materials Survey Report

**Former Norwich State Hospital
Ribicoff Building
Circle B South
Preston, Connecticut**

**M&A Project No. 7055001.000
October 28, 2010**

**Mabbett & Associates, Inc.
Environmental Consultants & Engineers**

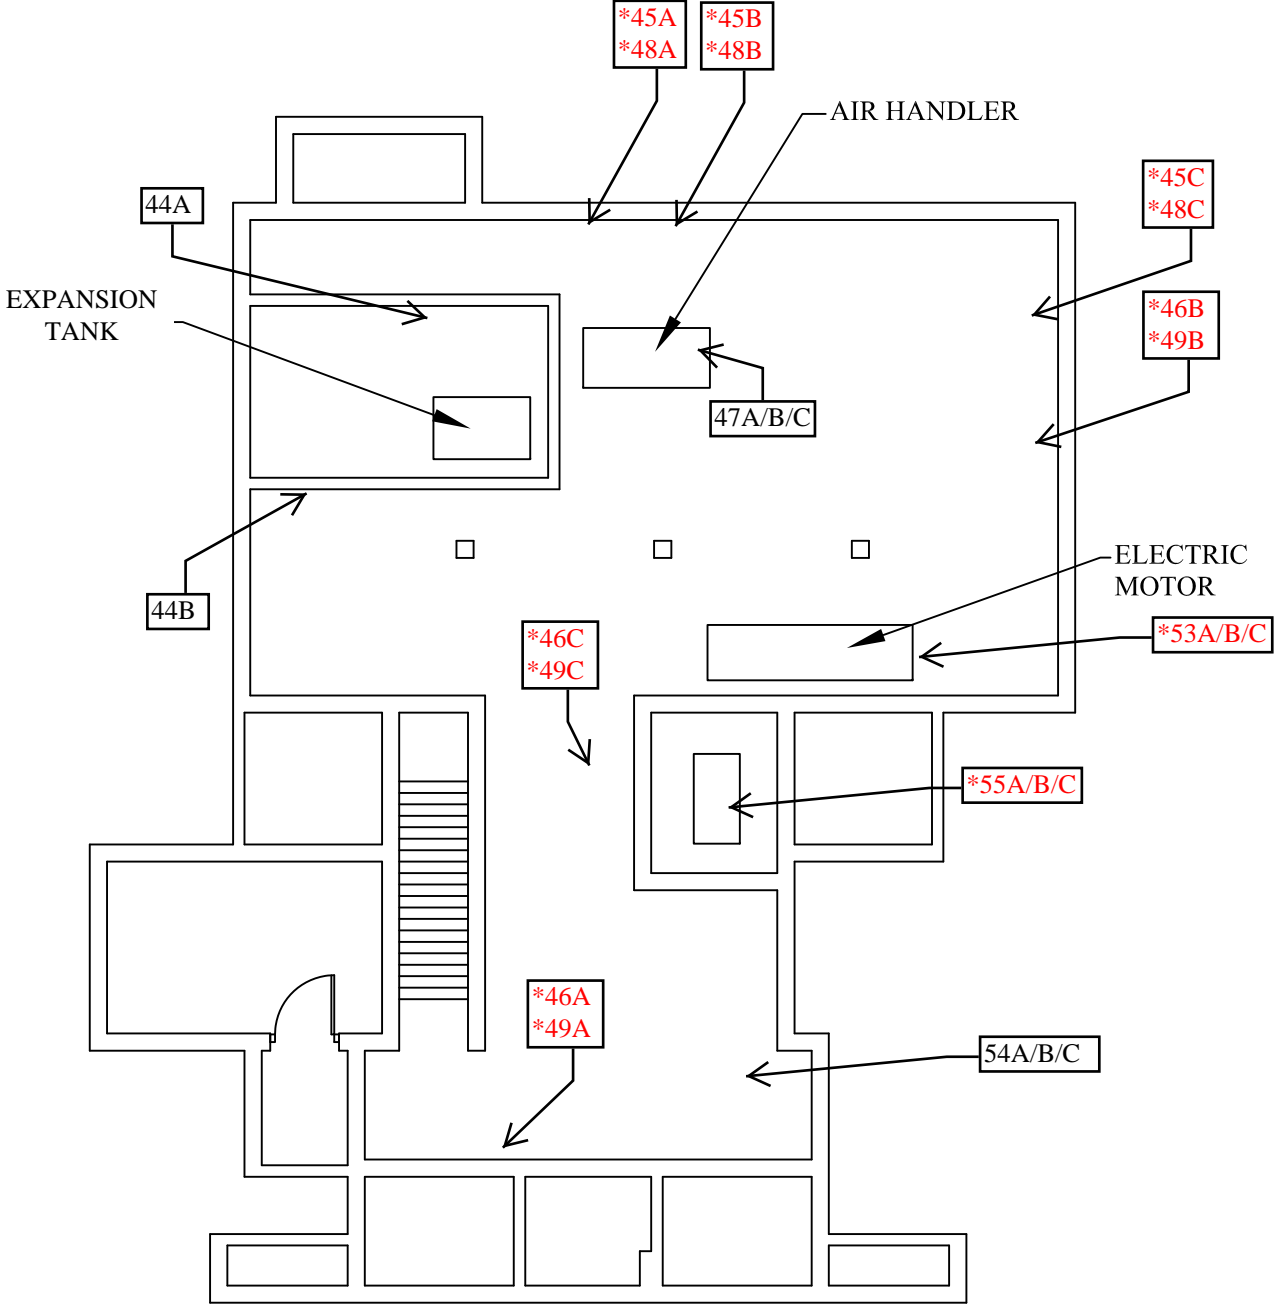
BASEMENT

Basement black solid pipe insulation is ACM (see sample 53)

Basement electrical mounting board is ACM (see sample 55)

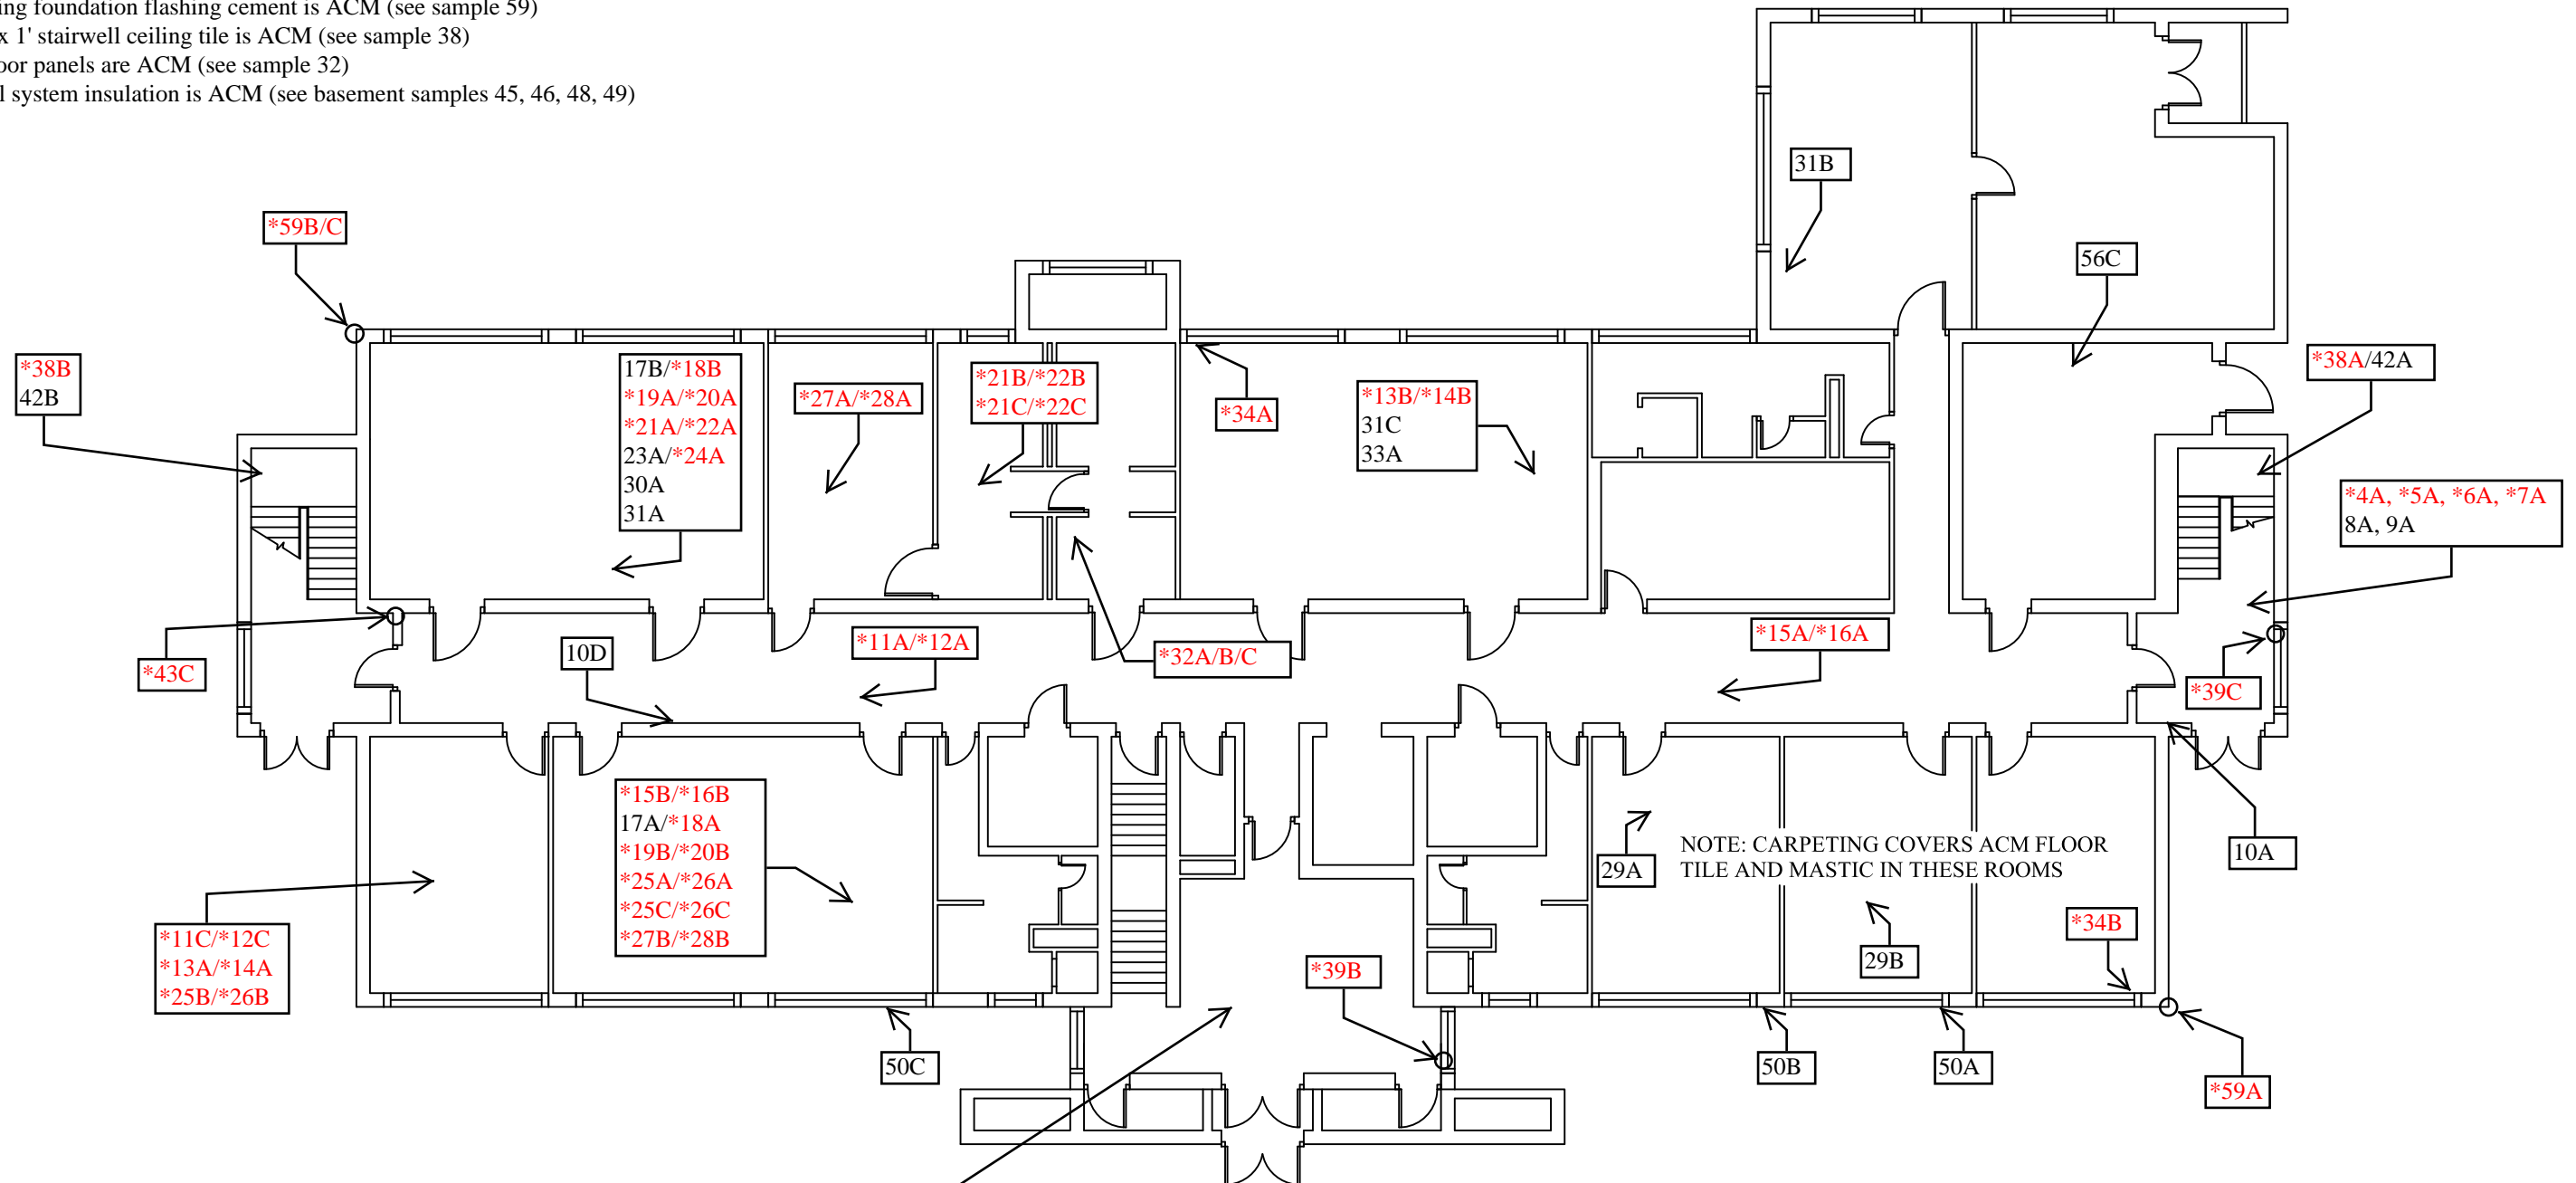
All ground floor 9" x 9" vinyl floor tiles and mastics are ACM
All 12" x 12" vinyl floor tile mastic is ACM
All thick, chalky, white window glaze is ACM (see sample 34)
All caulk between interior doors and building walls is ACM (see sample 43)
All window glaze gaskets are ACM (see sample 39)
All exterior building foundation flashing cement is ACM (see sample 59)
Glue daubs on 1' x 1' stairwell ceiling tile is ACM (see sample 38)
Interior cabinet door panels are ACM (see sample 32)
Bathroom thermal system insulation is ACM (see basement samples 45, 46, 48, 49)

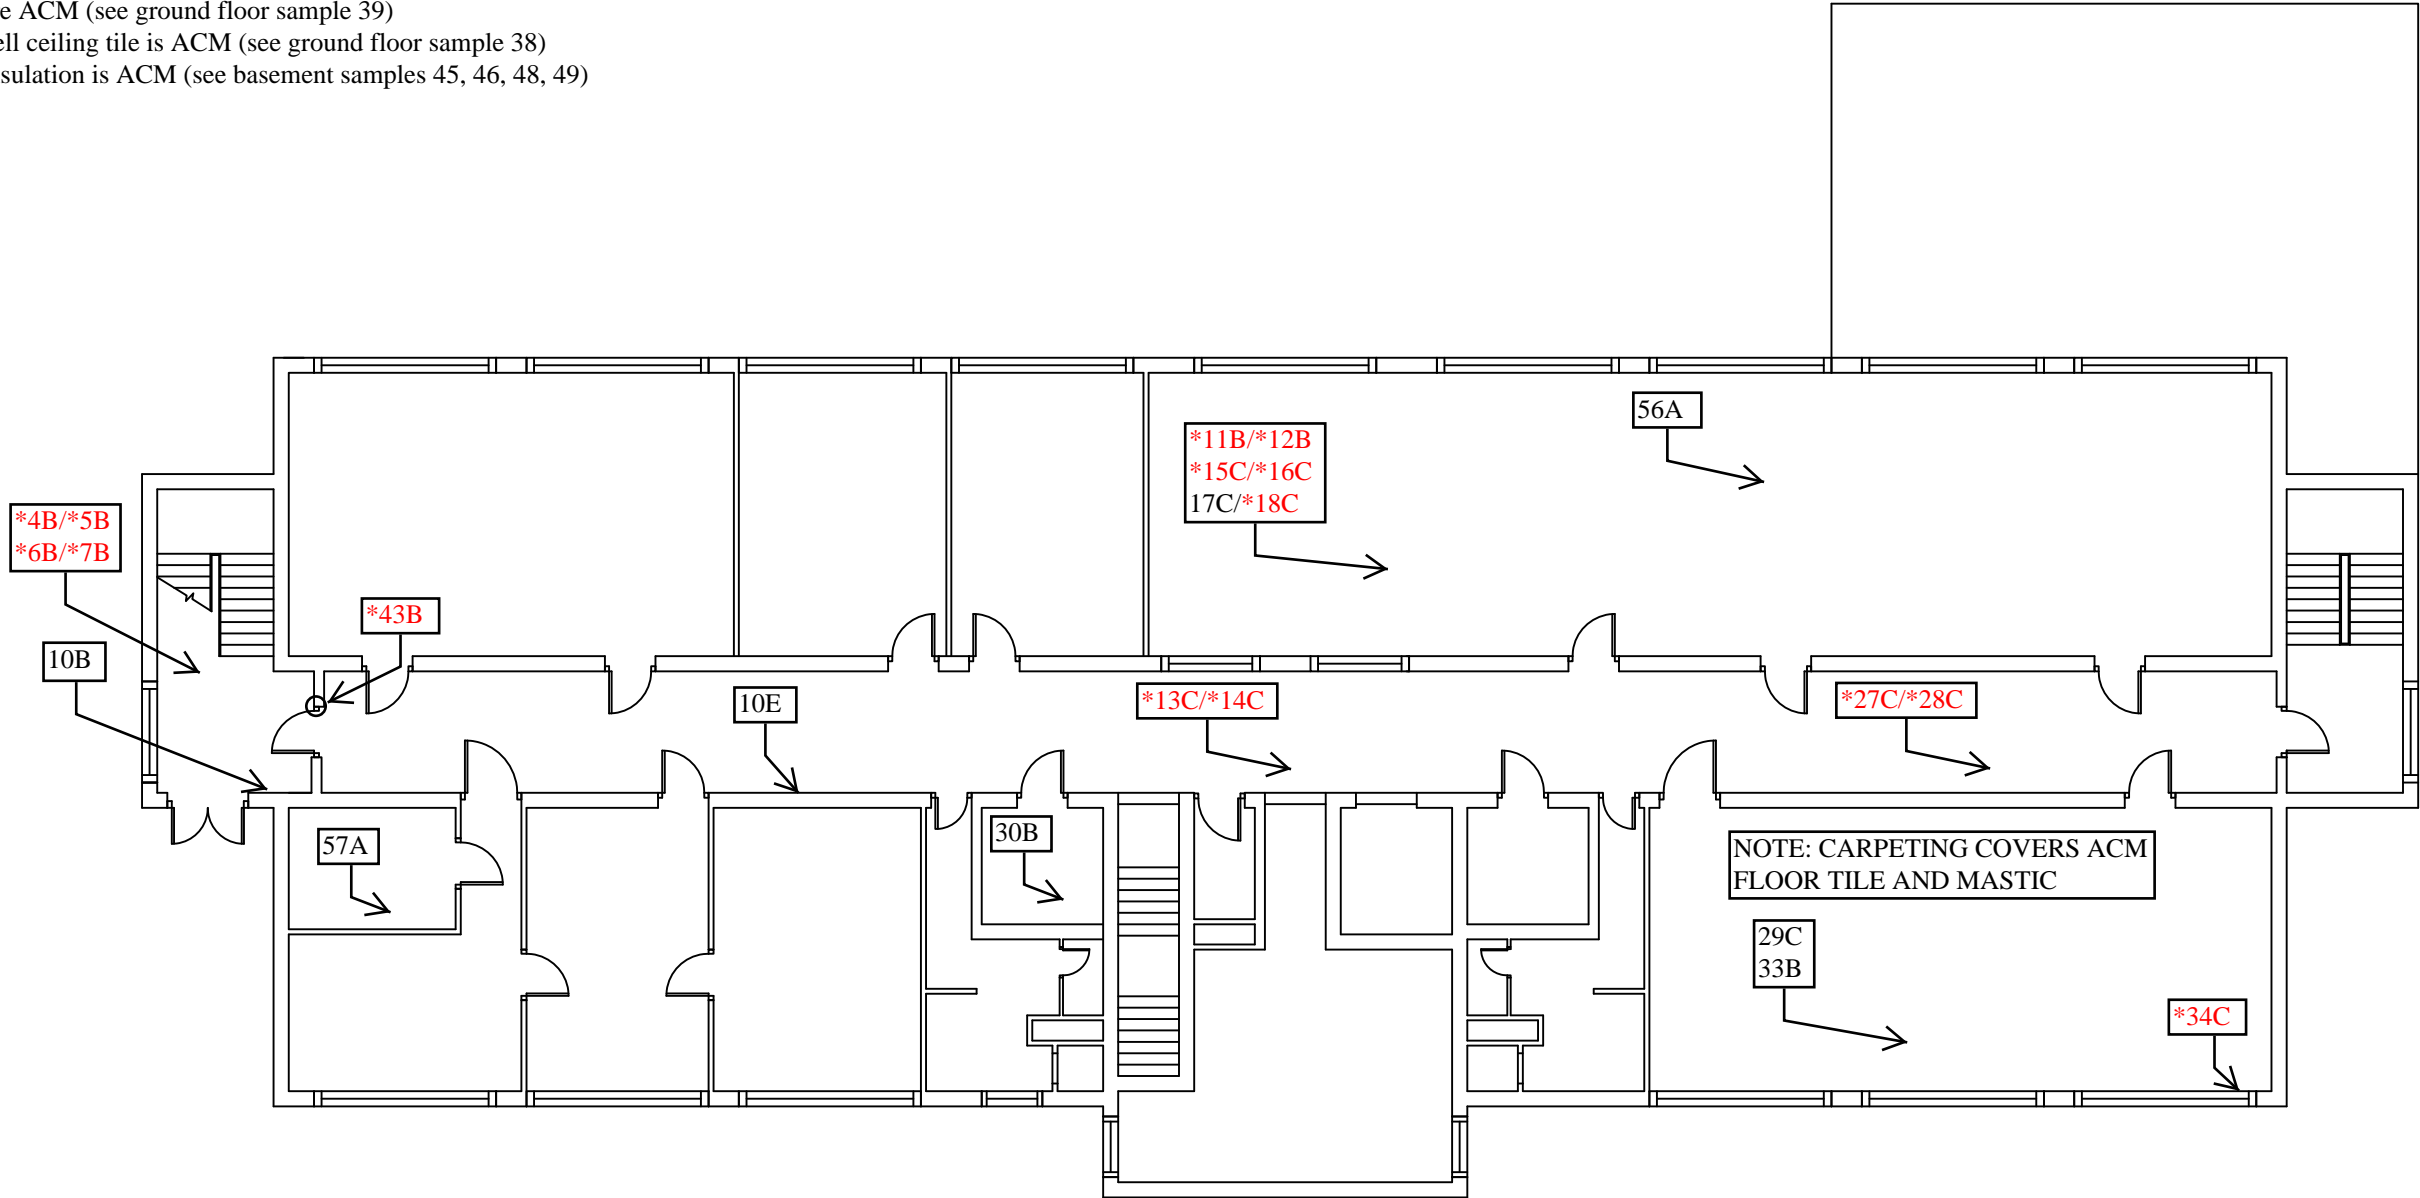
SECOND FLOOR

- All second floor 9" x 9" vinyl floor tiles and mastics are ACM
- All second floor 12" x 12" vinyl floor tiles and mastics are ACM
- All thick, chalky, white window glaze is ACM (see sample 34)
- All caulk between interior doors and building walls is ACM (see sample 43)
- All window glaze gaskets are ACM (see ground floor sample 39)
- Glue daubs on 1' x 1' stairwell ceiling tile is ACM (see ground floor sample 38)
- Bathroom thermal system insulation is ACM (see basement samples 45, 46, 48, 49)

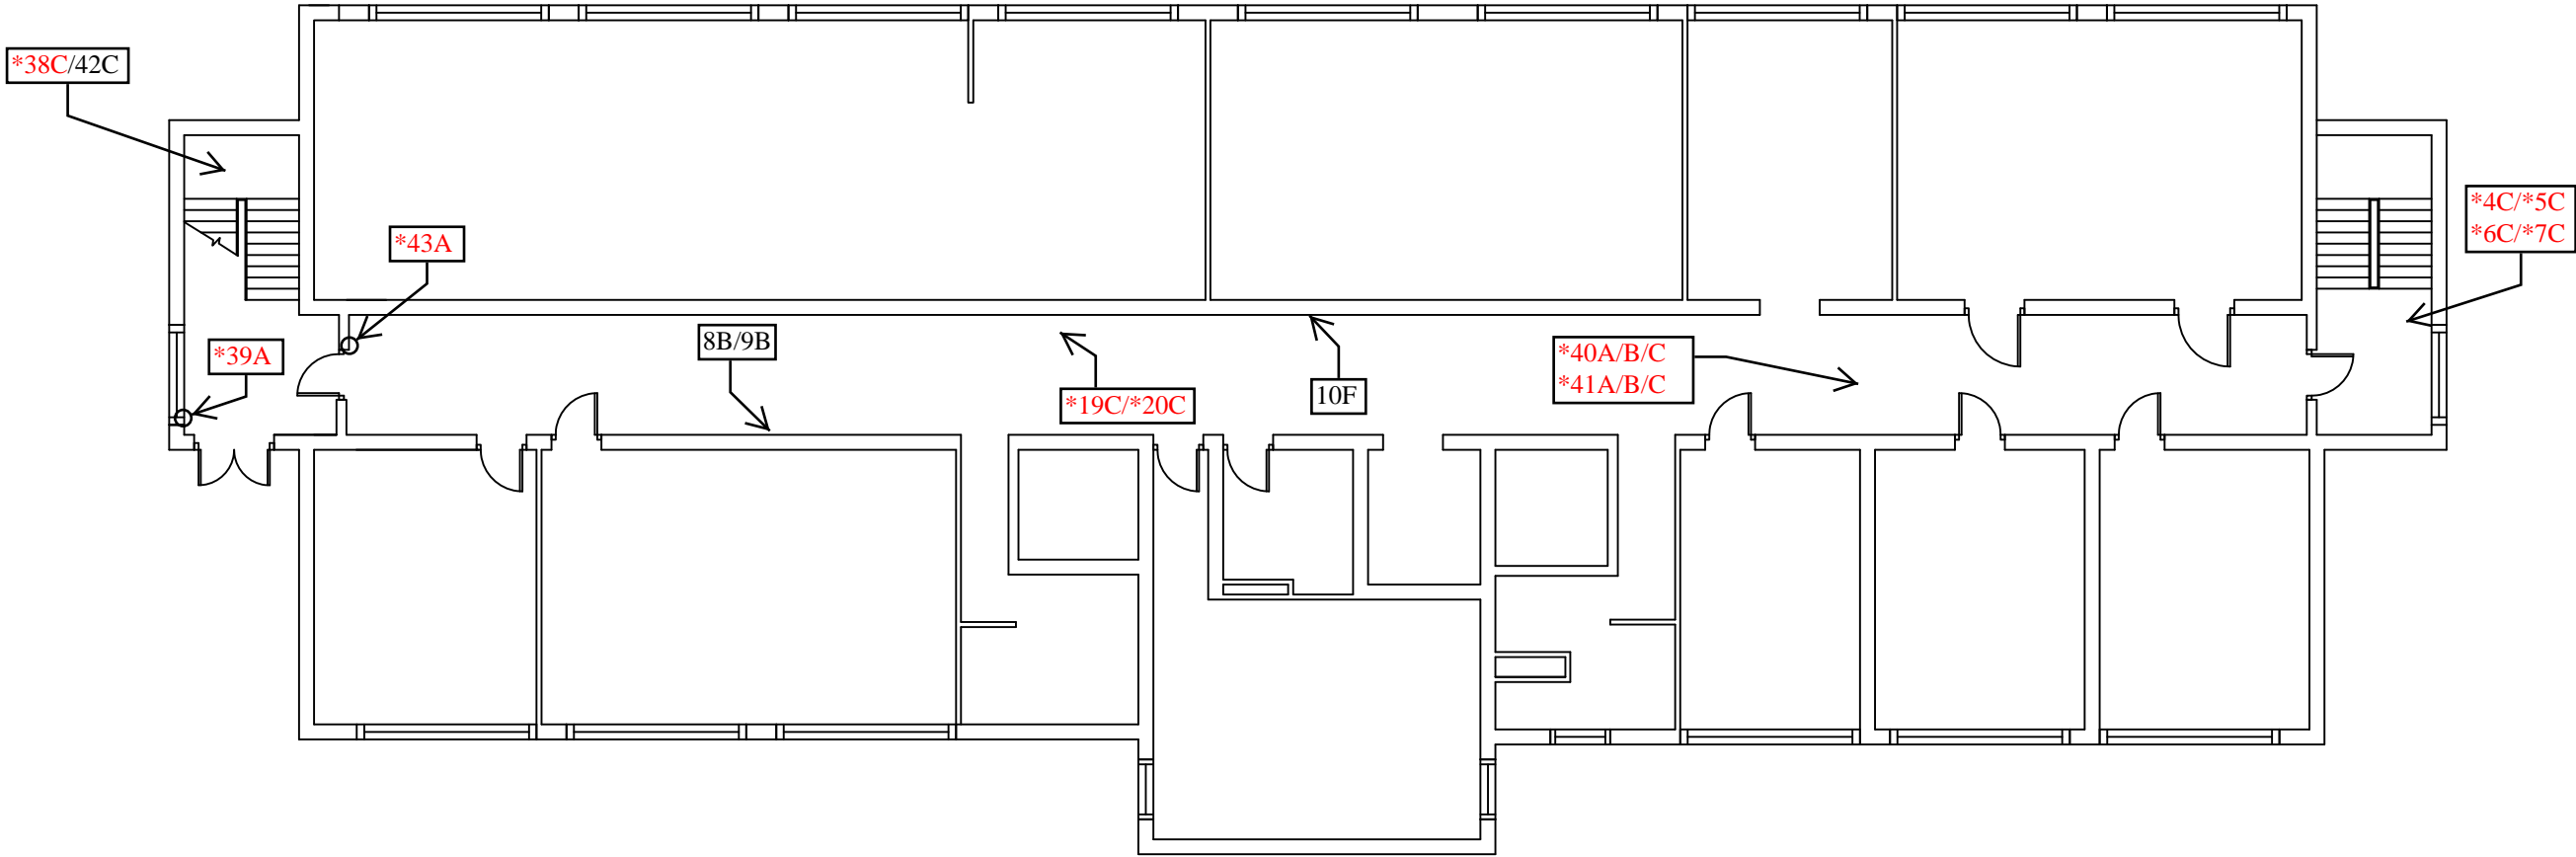
THIRD FLOOR

Carpet covers all third floor ACM floor tile and mastic except in hallways
All third floor 9" x 9" vinyl floor tiles and mastics are ACM
All thick, chalky, white window glaze is ACM (see ground floor sample 34)
All caulk between interior doors and building walls is ACM (see sample 43)
All window glaze gaskets are ACM (see sample 39)
Glue daubs on 1' x 1' stairwell ceiling tile is ACM (see ground floor sample 38)
Bathroom thermal system insulation is ACM (see basement samples 45, 46, 48, 49)

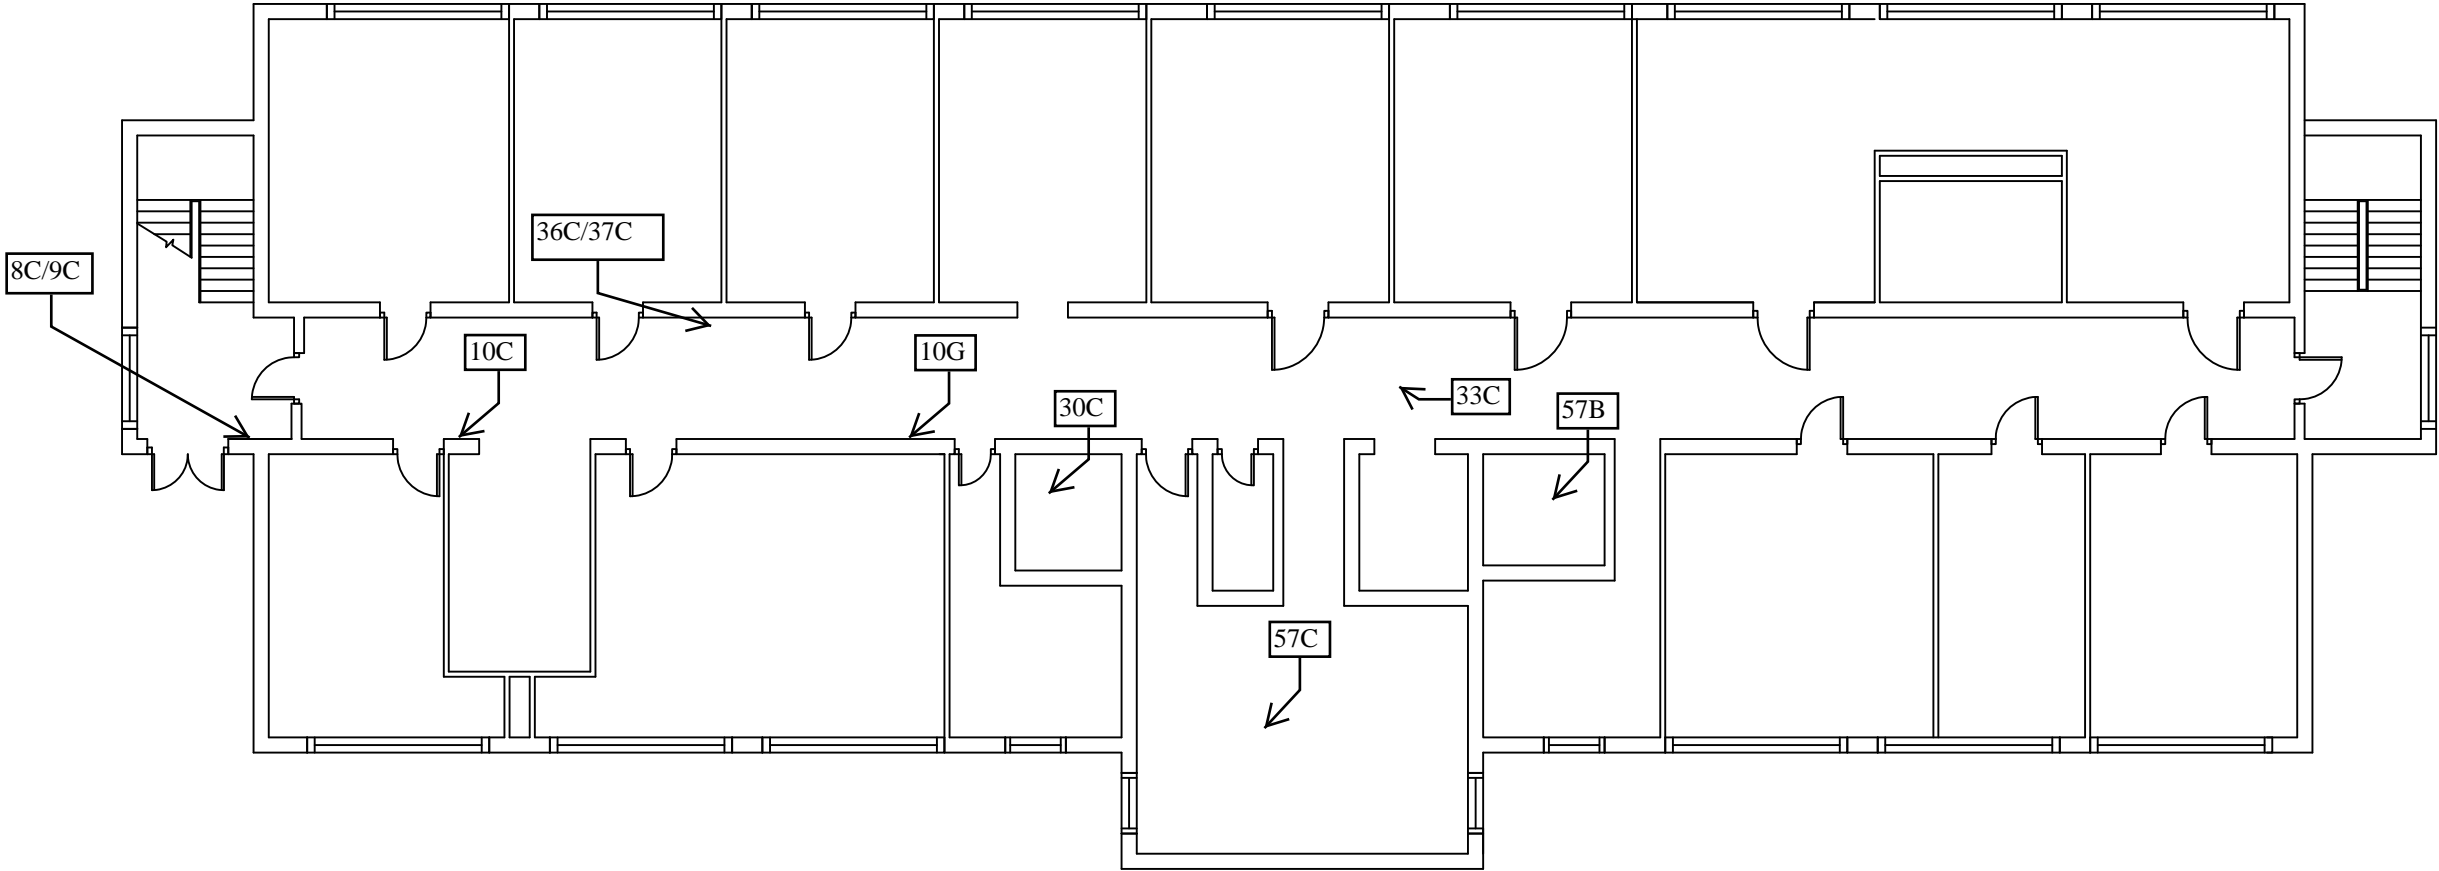
FOURTH FLOOR

- All fourth floor floors are terrazzo or concrete
- All thick, chalky, white window glaze is ACM (see sample 34)
- All caulk between interior doors and building walls is ACM (see sample 43)
- All window glaze gaskets are ACM (see sample 39)
- Glue daubs on 1' x 1' stairwell ceiling tile are ACM (see ground floor sample 38)
- Bathroom thermal system insulation is ACM (see basement samples 45, 46, 48, 49)

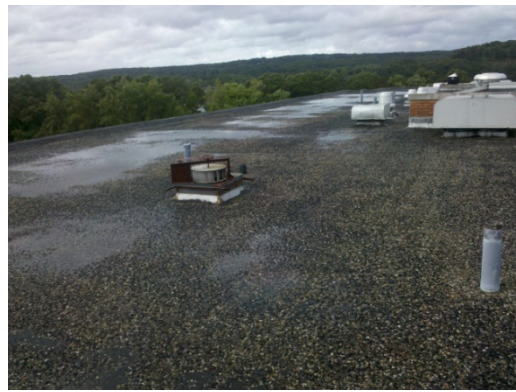
Asphalt and gravel roof, tar paper under roof
Samples 1, 2

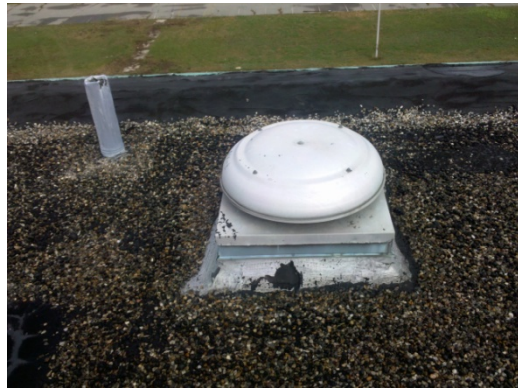
Silver painted flashing cement
Sample 3

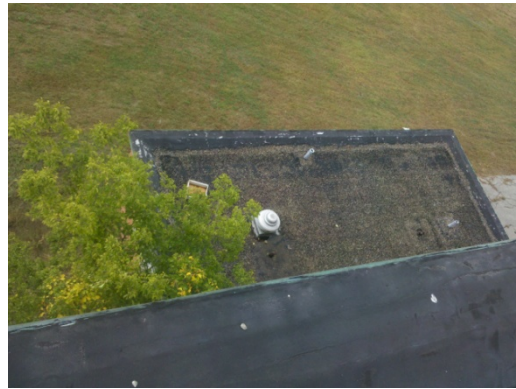
Morgue roof, similar to main roof
Samples 1, 2, 3

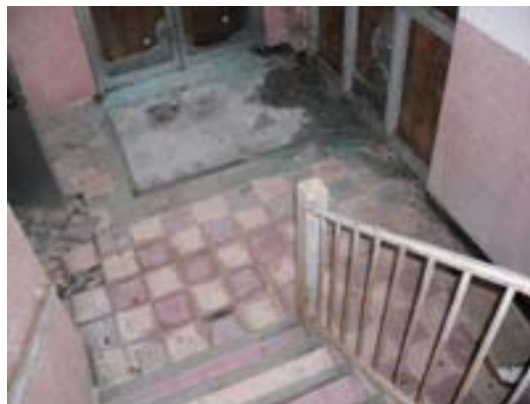
9" x 9" Pink and red floor tile
Samples 4, 5, 6, 7

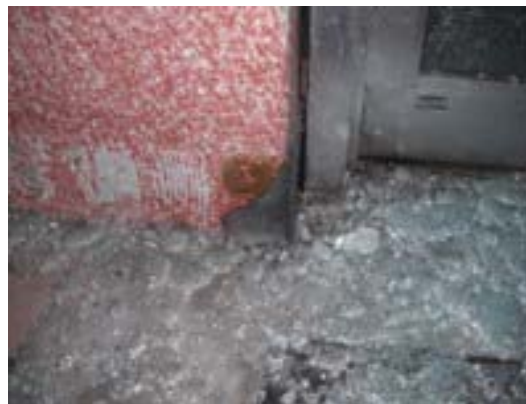
Cove base and mastic
Samples 8 and 9

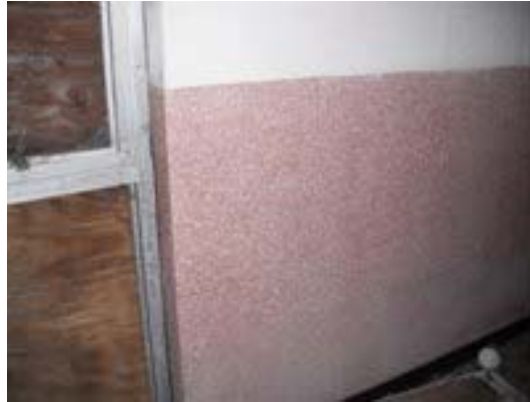
Textured surface material
Sample 10

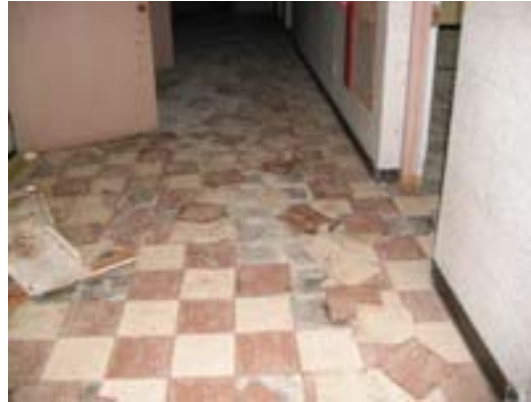
9" x 9" Maroon and off-white tiles and mastic
Samples 11, 12, 15, 16

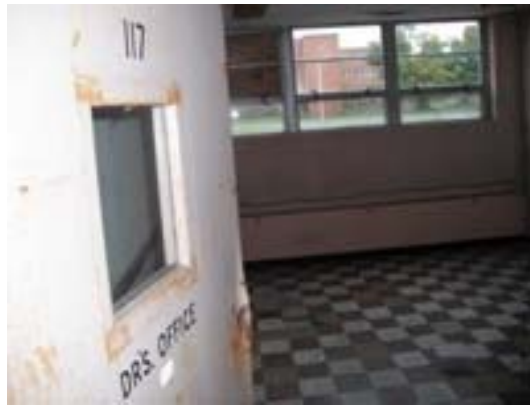
9" x 9" White tile and mastic
Samples 13, 14

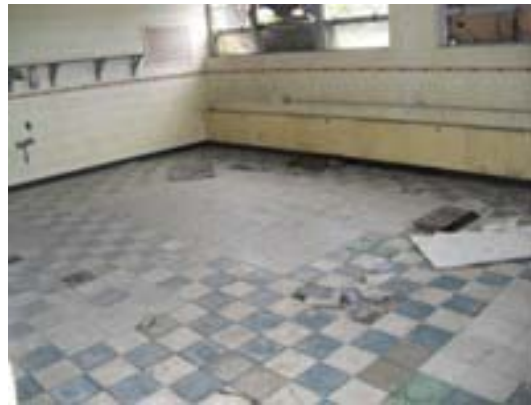
12" x 12" White tile & mastic
Samples 17, 18

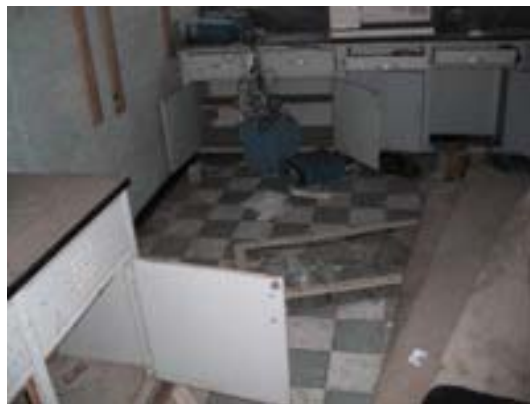
9" x 9" Green tile and mastic
Samples 19, 20

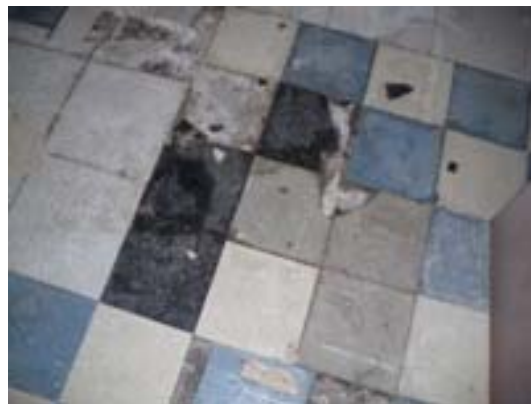
9" x 9" Black tile and mastic
Samples 21, 22

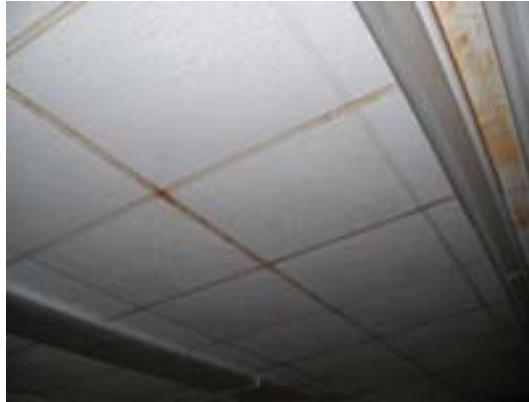
2' x 2' Ceiling tile
Sample 33

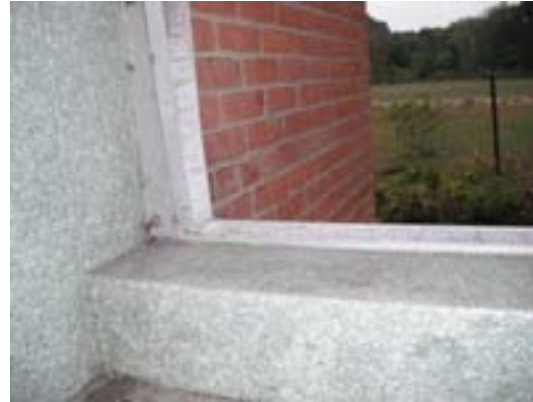
Window glazing
Sample 34

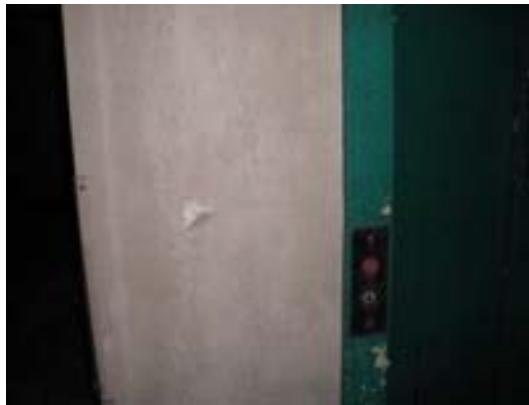
Plaster skim coat under wall paper
Sample 35

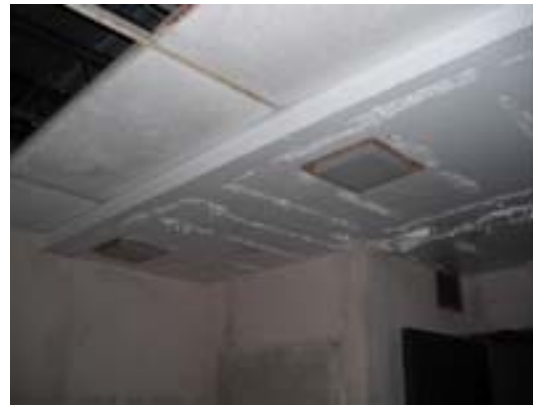
Dry wall and joint compound
Samples 36, 37

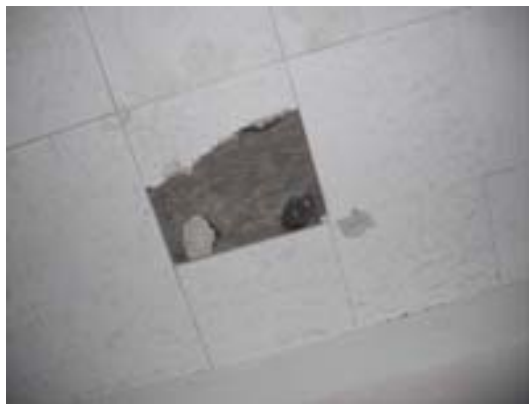
- Black solid pipe wrap - 40% Chrysotile
- Electrical mounting board - 30% Chrysotile
- Building foundation black flashing cement - 30% Chrysotile
- Brown glue dabs on 1' x 1' ceiling tiles – trace and previously 2 – 2.5% Chrysotile

1' x 1' Ceiling tile and glue daubs
Samples 38, 42

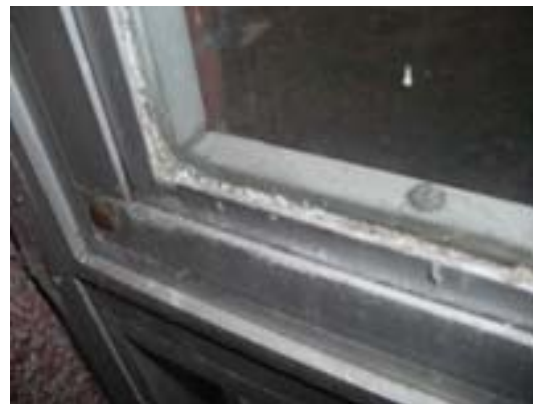
Window gasket glaze, type II
Sample 39

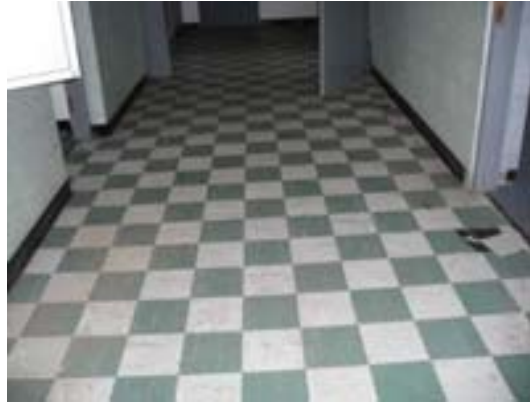
9" x 9" White with green streaks tile and mastic
Samples 40, 41

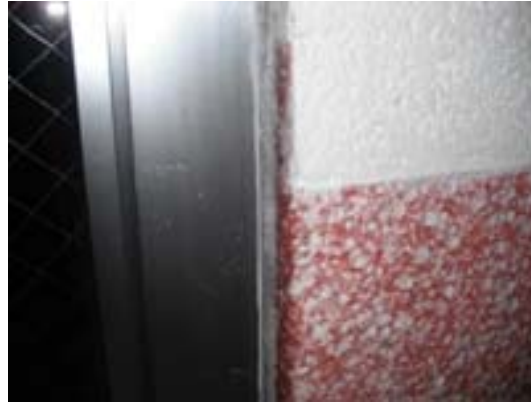
Caulk between wall and door partitions
Sample 43

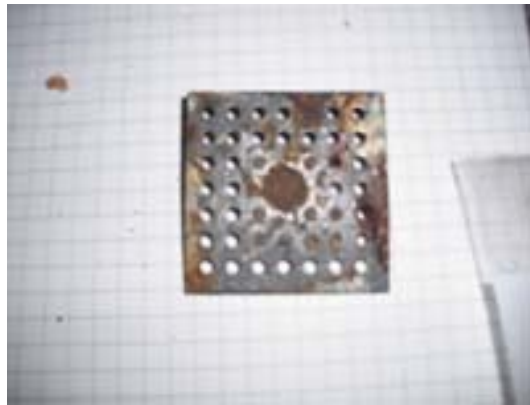
Adhesive on metal brackets
Sample 44

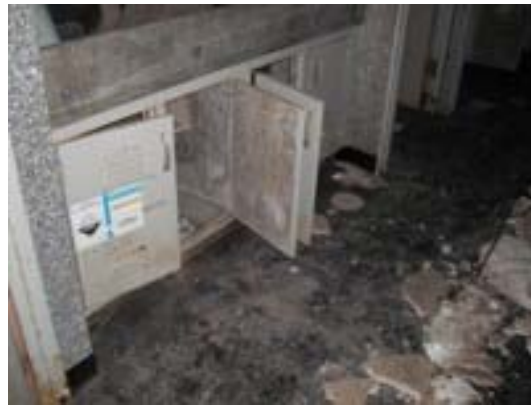
Panels inside cupboards
Sample 32

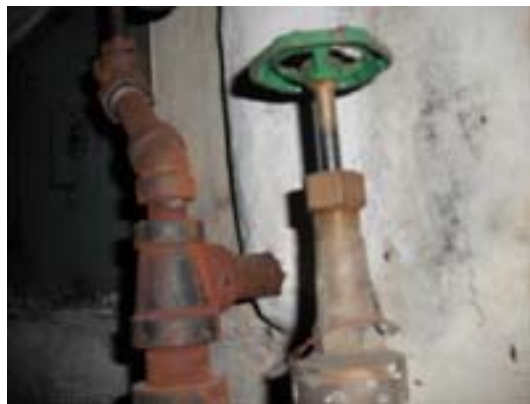
Thermal system insulation, >6"
Sample 45

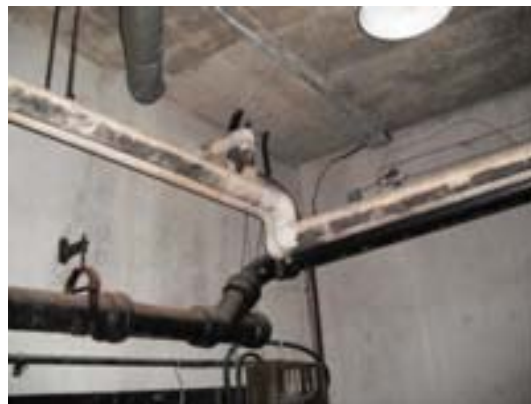
Thermal system insulation, <6"
Sample 46

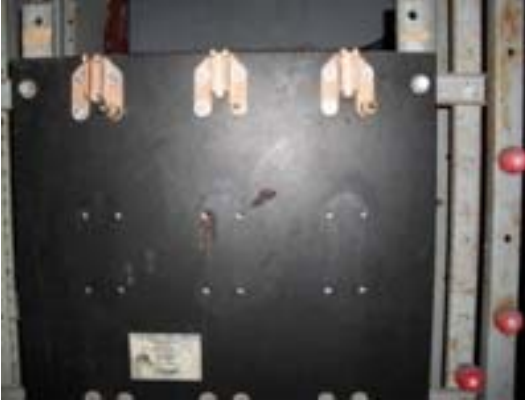
<p>Electrical mounting board Sample 55</p>

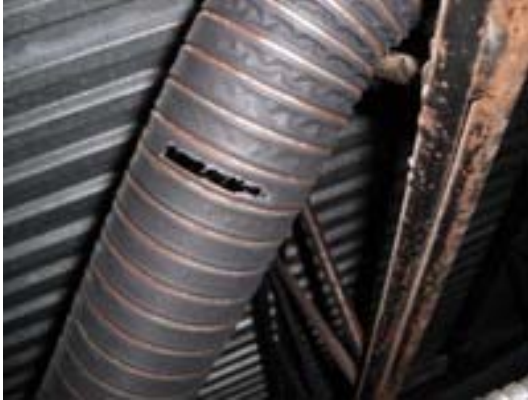
<p>Black flexible hose duct on amostat Sample 56</p>

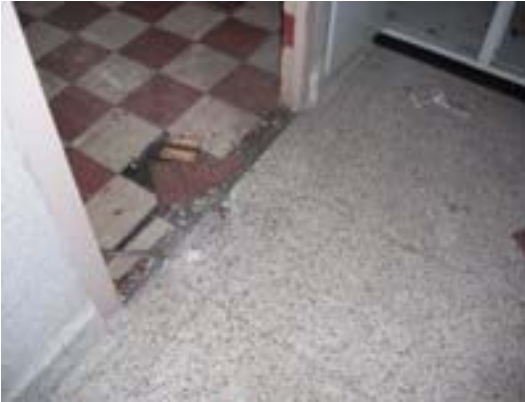
<p>Terrazzo flooring Sample 57</p>

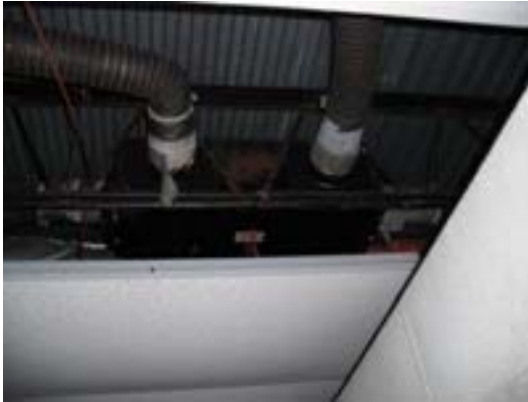
<p>Felt insulation on amostat Sample 58</p>

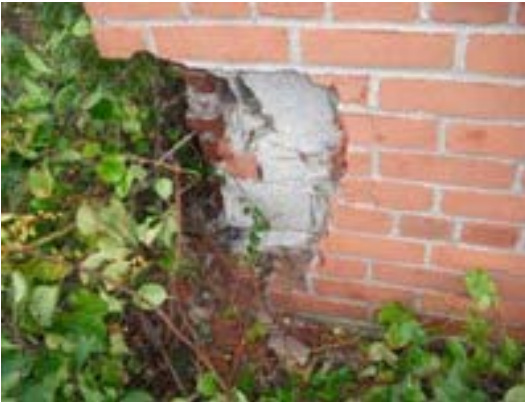
<p>Black flashing cement on building footing Sample 59</p>	<p>Intentionally blank</p>
